The Yellowstone River Cumulative Effects Analysis—15 Years in the Making

**The Upper Yellowstone
Examining the Confluence of Past Lessons and
Future Needs**

Karin Boyd, AGI

Yellowstone River Cumulative Effects Analysis

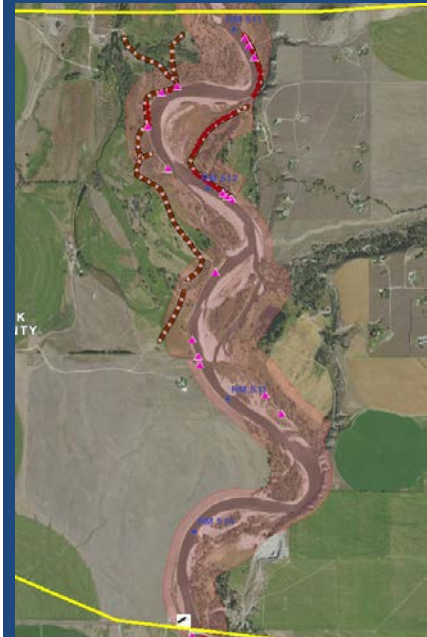
Reach PC10 extends from the Pine Creek Bridge to below the mouth of Deep Creek. The reach is approximately 3.5 miles long, extending from RM 511.0 to RM 514.5. This is an especially unique section of the Yellowstone River where spring creeks that parallel the channel support a nationally recognized cold water fishery. The reach is also semi-confined by very coarse grained glacial alluvial terraces. Sediment recruitment from the terraces drives bar formation, resulting in locally rapid bank migration, and in some cases, threats to the spring creeks. This was exemplified during the 1996/1997 floods, when the river migrated tens of feet into high glacial terraces, delivering vast amounts of gravel to the channel. At one location near the Deep Creek confluence, a home on a ~30 foot high glacial terrace was undermined and deliberately burnt down to prevent its collapse into the river. Just downstream of this site, rapid point bar growth drove westward channel migration towards a prized spring creek, which created a real risk of Yellowstone River avulsion into that channel. Efforts to prevent an avulsion included sediment removal from the rapidly enlarging point bar, bank protection, and construction of a long floodplain dike between the spring creek and the river. This single bendway experienced approximately 750 feet of migration between 1948 and 1999, which translates to an average migration rate of 14.7 feet per year.

Approximately 14 percent of the bankline is armored, primarily by rock riprap (3,753 feet) and flow deflectors (1,197 feet). Between 2001 and 2011, the net length of bank armor increased by 1,037 feet, although 50 feet of flow deflectors were eroded out during that time. There are also over two miles of floodplain dikes in the reach, most of which run parallel to the river to isolate the spring creeks. Several thousand feet of side channels have been blocked in Reach PC10; one large channel that was blocked prior to 1950 extends downstream for several thousand feet into Reach PC11. There is a high concentration of emergent wetlands in these abandoned side channels.

The total bankfull channel area in Reach PC10 increased from 151 acres in 1950 to 191 acres in 2001, suggesting channel enlargement, either due to floods or flow concentrations in the main channel due to side channel loss and diking.

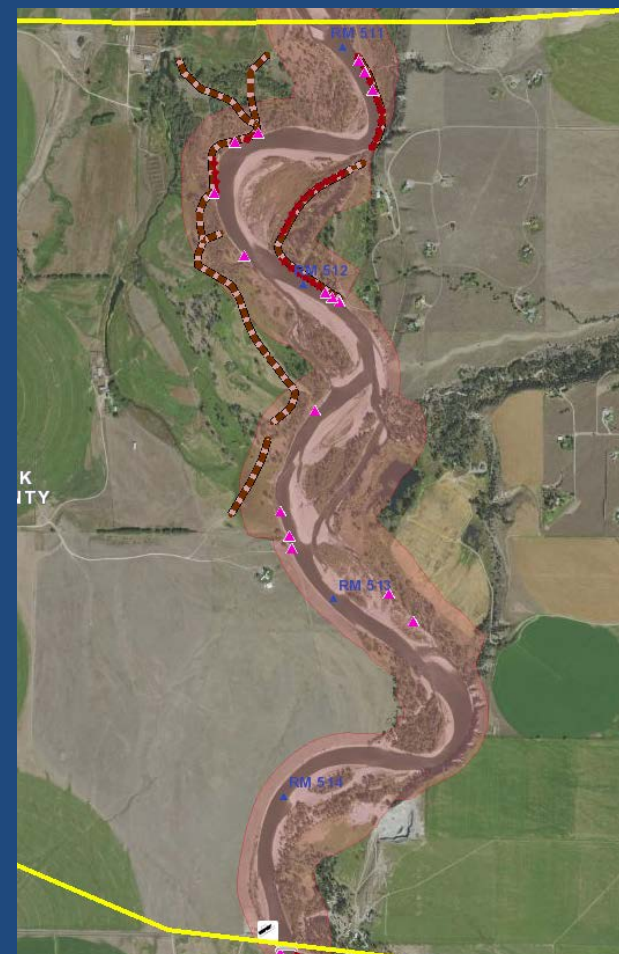
Reach PC10

The following table summarizes some key CEA results that have been used to describe overall condition and types of human influences affecting the river. The values are specific to this single reach. Blanks indicate that a particular value was not available for this area. This information is consolidated from a large dataset that is presented in more detail in the full reach narrative report.

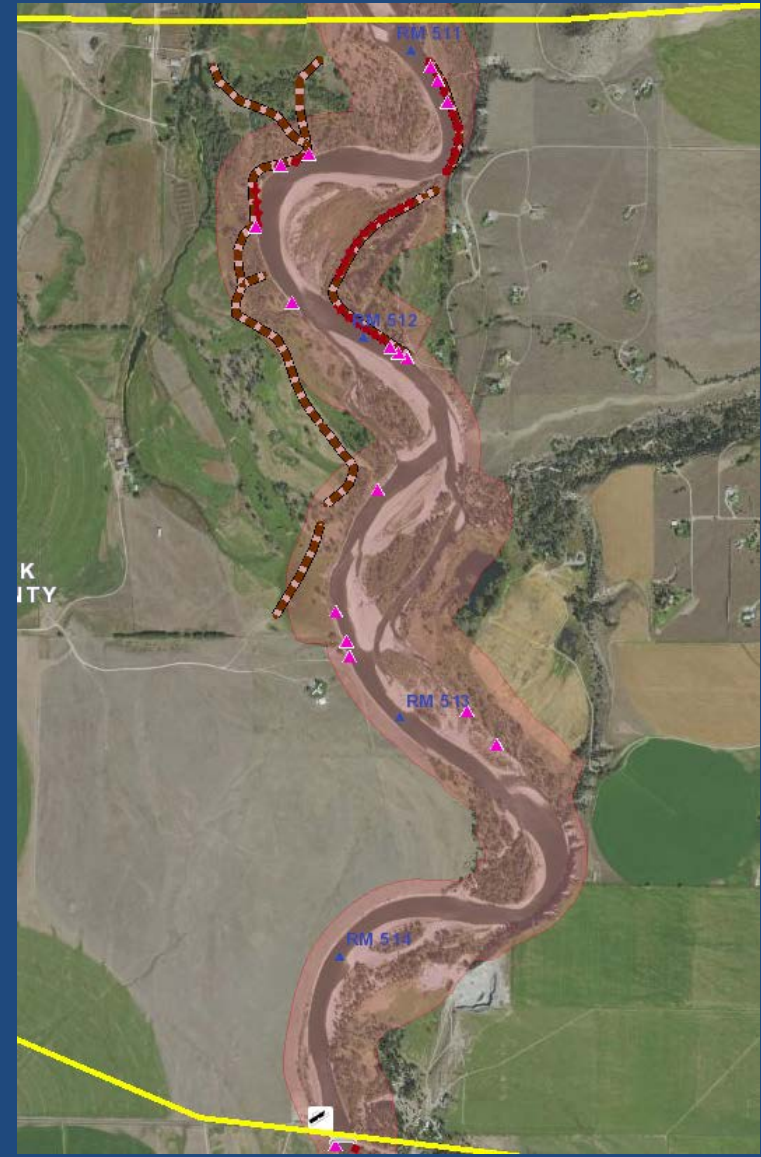
CEA-Related observations in Reach PC10 include:

- Extensive dike construction - Floodplain dikes constructed to protect spring creek fisheries have narrowed the active meander corridor
- Exurban encroachment into the Channel Migration Zone (CMZ) has occurred on terrace surfaces
- Gravel pit and recreational pond development in a meander core may contribute to avulsion risk in the reach.
- Rapid dike construction and armoring following major flooding (1996/1997).
- Increase in primary channel length (sinuosity) with loss of side channels.
- Isolation of 38 percent of the CMZ, mostly avulsion hazard areas that support spring creeks.

- YRRP 1.2 - Floodplain Restoration – Public Highways and County Roads
- YRRP 1.3 - Side Channel Blockage Removal - Side Channel Restoration
- YRRP 3.2 - Invasive Woody Plant Control - Russian Olive Control
- Selective side channel restoration at RM 511.5 (may be difficult to reactivate side channels without affecting developed spring creek fishery)
- CMZ Management due to current restriction of 38 percent of the Channel Migration Zone
